C600 Theatre Organ Project

Part-1

C600 Organ Project. Part-1 Building the Console

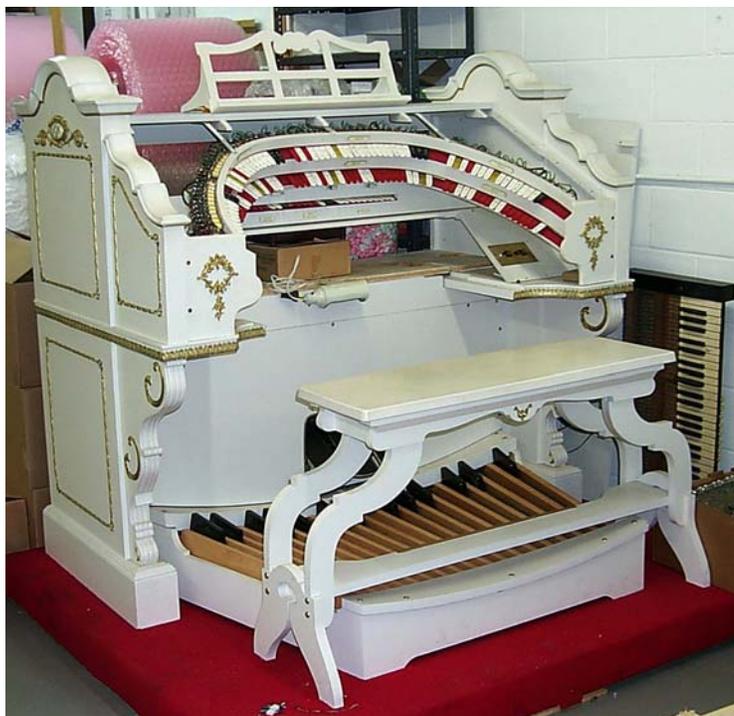
The Beast, having been gutted, resides at Classic Organ Works. Keyboards are missing. The pedal lamp uses an old aerosol tin.

Accordingly, the decision was made to gut it completely, leaving only the keys, tabs and pedalboard. A state-of-the-art Classic combination-action control system would be used that would provide many desirable features hitherto almost impossible to implement. Whatever tonal system might be used could be thought about later

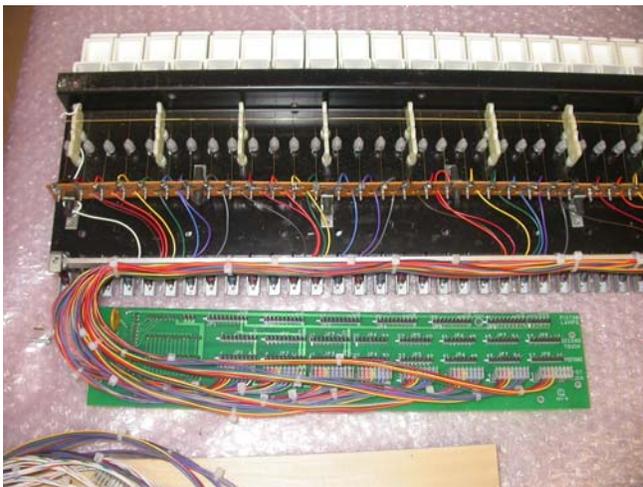
The Solo keyboard

Two of the keyboards had second-touch contacts and extra bushes to give the extra pressure at the bottom of the key travel. Each keyboard used springy wire contacts that pressed against silver-plated rods running the length of the keyboard — two sets for second touch keyboards. The silver-plated rods were in a very oxidized condition and obviously had not been cleaned in years. A preliminary cleaning of one showed that the contacts were usable although inclined to be intermittent. As built, that would have been a major problem since the contacts switched very low-level signals at relatively low impedances where contact resistance was a major factor, but with the Classic sys-

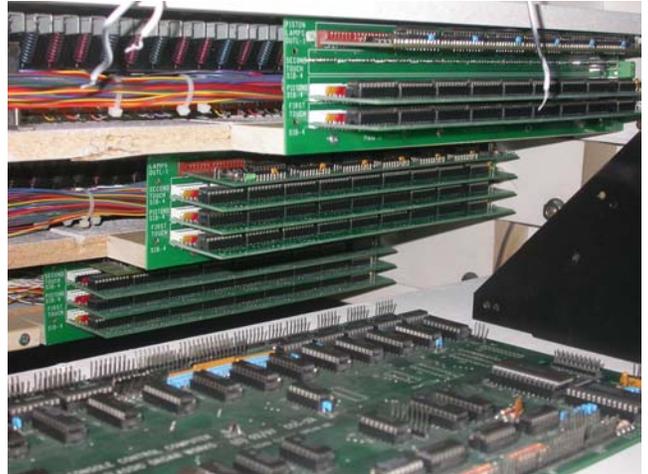
The keyboards were not a good design as they were mounted on half-inch particle board used as a base under all the contacts. Consequently, there was no way to adjust the contacts once it had been assembled. Therefore, a large aperture the length of the keyboard was cut in each base for access from beneath. The three keyboards assembled into a single unit with the use of triangular wooden brackets at the sides that allowed each keyboard to be pivoted upwards for adjustments. However, there was a snag with these brackets because the aperture through the front of the console was no wider than the key cheeks and the brackets would not go through as well. Accordingly, the brackets were replaced by custom-made metal ones mounted inside the cheeks. All seemed well and the set of keyboards was installed temporarily to see what problems there might be. It was immediately apparent that the keyboards could not be raised individually because of the proximity of the stop tabs immediately above the top keyboard unless the entire assembly was pulled forward — and it would have to be pulled so far forward that it would be off the keyboard. It was decided to leave that particular problem until later and continue with wiring. The keyboards could at least be removed and, if the cables were long enough, as a working entity so that adjustments would be possible. Failing that, extension cables could always be employed.

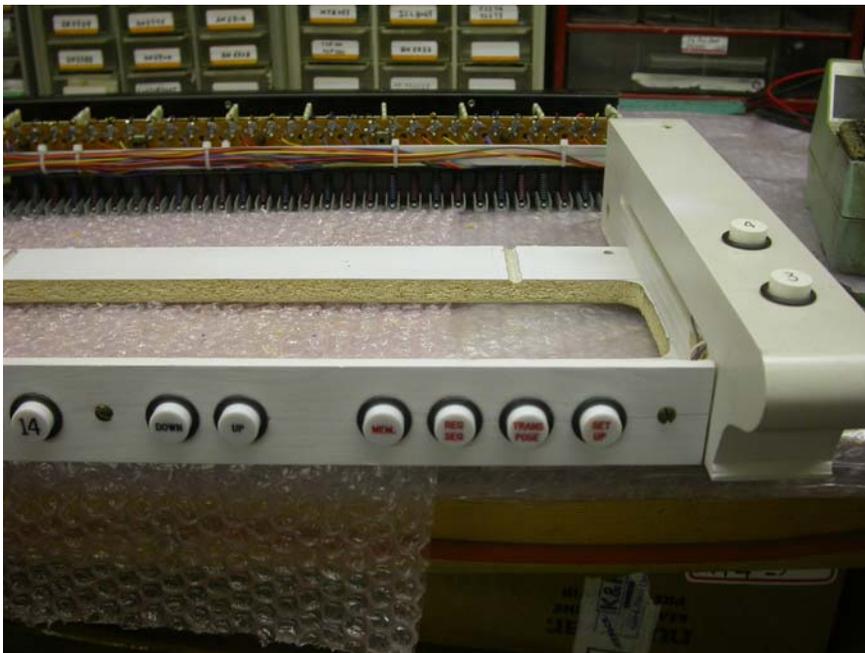
The old piston rails had been removed and new ones were to be made with many more pistons that could be incorporated into the Classic control system to use its additional facilities. This involved rebating out the particle board base along the front edge to clear where the new pistons would go. At the same time, the key cheeks had their wiring grooves considerably enlarged to accept more piston wires because there were more pistons, many of which would also have lamps (none of the original pistons were lighted types). While that was being done, additional holes were bored in the top of the key cheeks to allow for two effects pistons on each one. Thus, there was the maximum capability of 28 pistons on each rail. The positions of the five mounting screws dictated that the piston layout be in four groups of seven at one-inch intervals after the outermost screws had been moved closer to the cheeks. This is one-eighth of an inch less than the usual standard for piston spacing but was deemed to be acceptable. Again, there was little room to rewire the pistons as a matrix so they would have to be wired wire-per-switch

fashion. The lamps would have to be done that way in any case as there was no place to put lamp-driving circuitry under the keys. New pistons were ordered from Syndyne and engraved at Classic. Plans were made to include the second-touch capability of these Syndyne pistons. The old pistons were reused where possible to save costs although their colour and engraving style did not quite match the new ones.

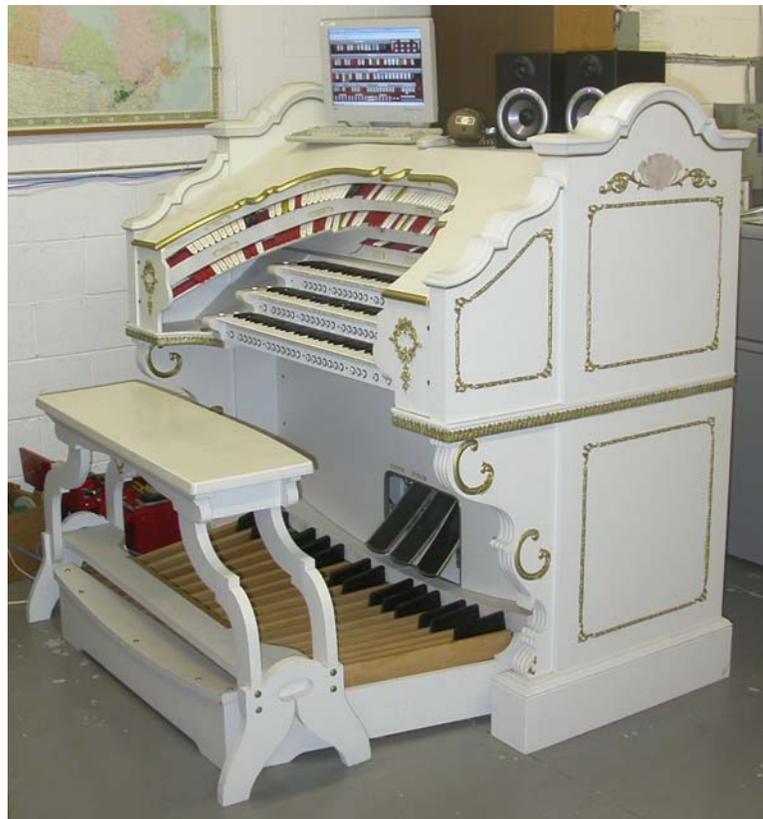
Working at last! The 2/8 Virginia Wurlitzer is on the screen.
